## CULVERT PIPE INSPECTION FORM

SITE # 130

CUSTOMER'S NAME Village of Wellington DISTRICT \_\_\_\_\_

LOCATION OF PIPE In Polo Club

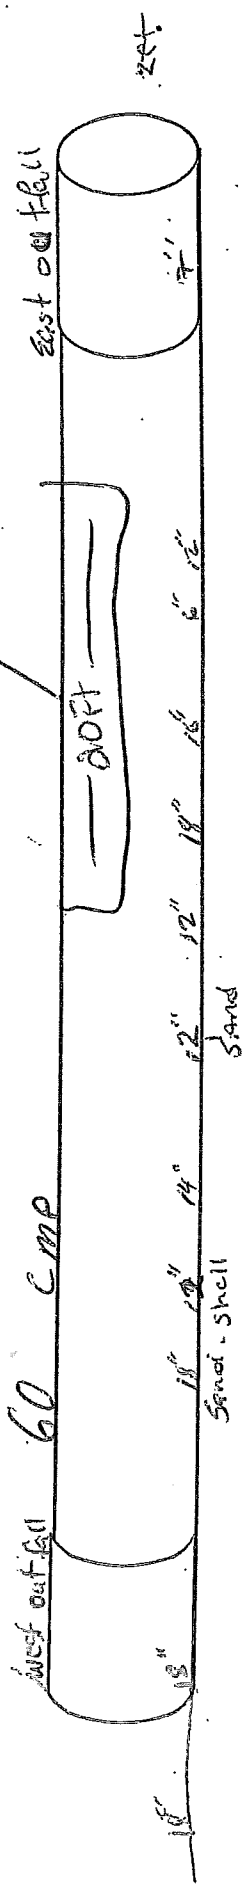
C. Culvert Profile

GENERAL CONDITION OF PIPE Pipe contained sand & shell mixture @ an average of 1d" the highest being 18" and lowest 7". 30' in from the east outfall the pipe is collapsed for almost 20'. See illustration on back

COMMENTS This pipe contained an average of 1d" of sand and needs cleaning. There is a 20' section of pipe towards the east outfall that has collapsed. Major repair or replacement may be necessary.

Notes: from 12 o'clock the pipe dent came in 18" <sup>3000K</sup> Aug-24 12/3

from bottom were the dirt came down 33" were the
