RE: Village of Wellington – Pump Station #8
14900 Pierson Road,
Wellington, FL 33414
Roof Condition Survey

ACRC #: 24-0295

ROOF SURVEY REPORT

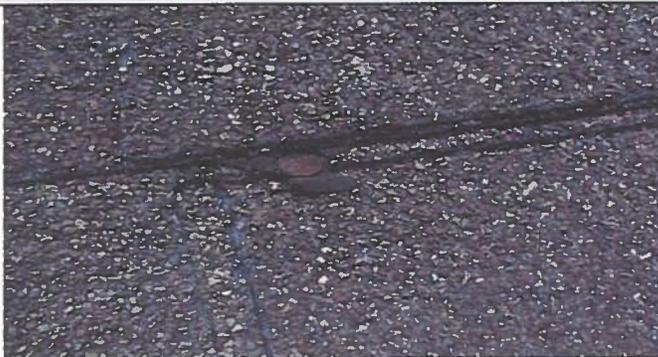
OBSERVATIONS AND DEFICIENCIES	ITEMS REQUIRING IMMEDIATE ATTENTION
<ul style="list-style-type: none"> Exposed nail rusting out Wearing of Shingle Granular loss 	<ul style="list-style-type: none"> Rusty exposed nail needs to be sealed water may penetrate. Delamination of Shingle Granules

PHOTO #2
**Close Up of low nail
rusting out**

RECOMMENTATIONS / SUMMARY
<p>This roof is at the end-of-life expectancy roof should be replaced within the next year. Re-Roof</p>

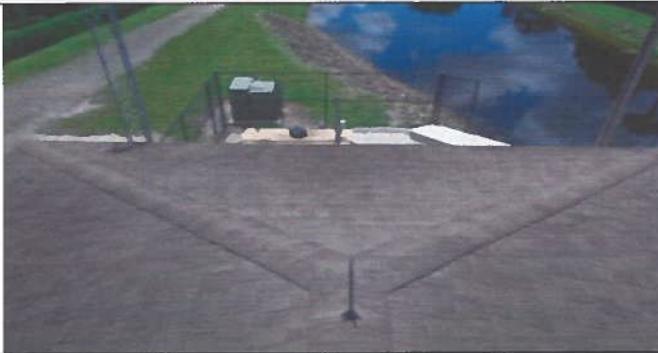
PHOTO #3
**Overview of weakened
Roof Shingles**

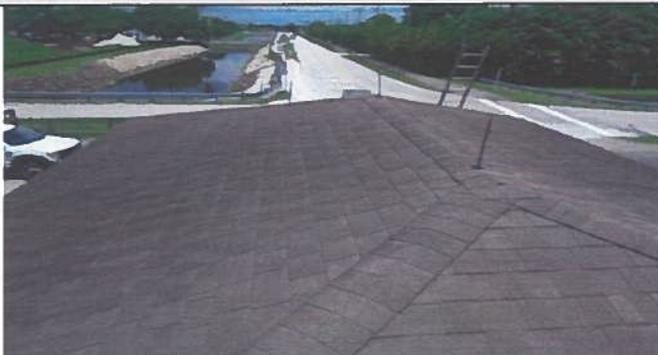
PHOTO #4
**Overview of weakened
Roof Shingles**

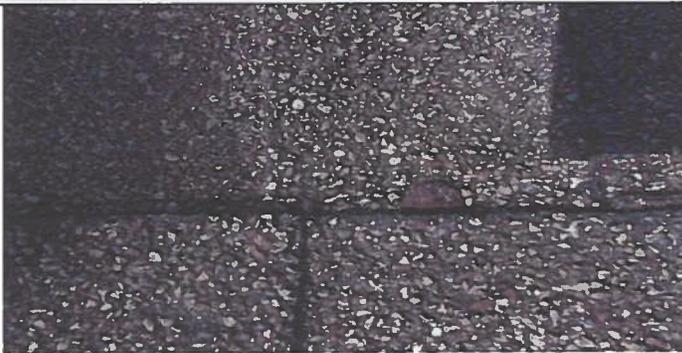
PHOTO #2

Close Up - Rusting Nail

RECOMMENDATIONS / SUMMARY
<p>This roof is at the end of its Useful Roof Service Life and should be replaced within the next year.</p>

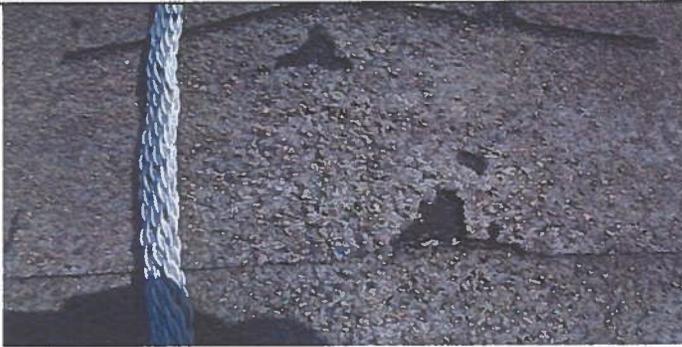
PHOTO #3

**Granular loss and
deteriorating Shingles**

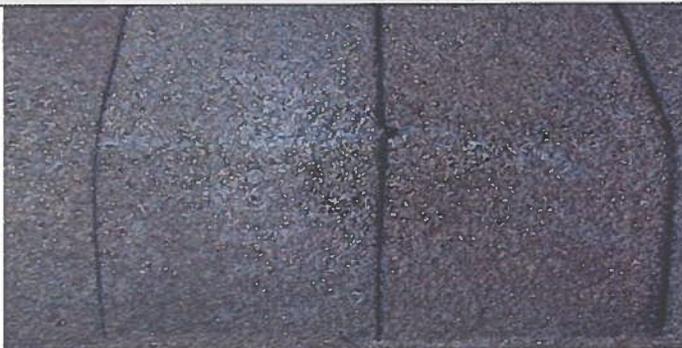
PHOTO #4

**Granular loss and
deteriorating Shingles**

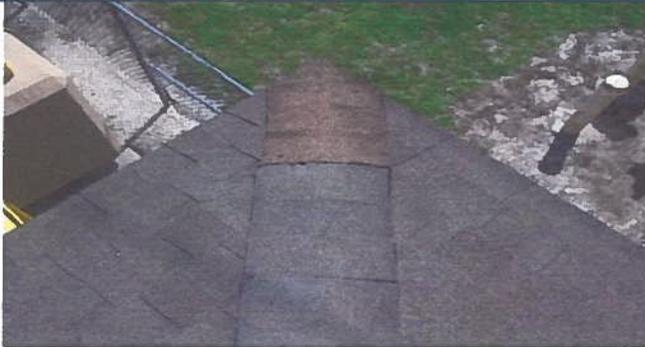
PHOTO #5
Repair at Ridge

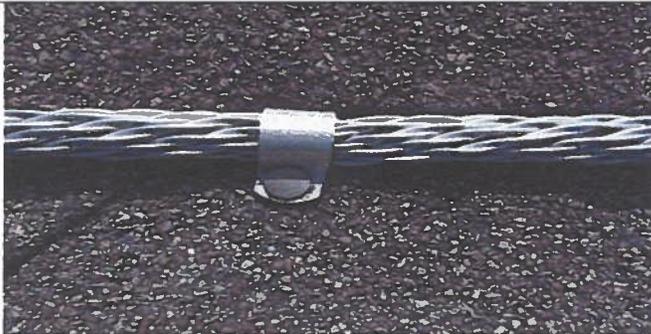
PHOTO #7
**Close Up exposed
Mechanical Fastener at
lightning protection cable**

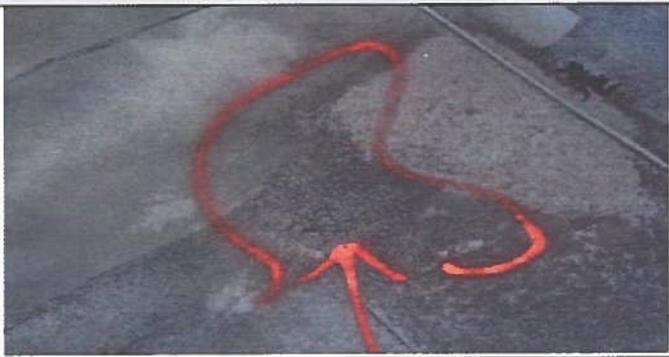
A photograph showing a dark, textured surface with red spray-painted markings, including a large irregular shape and an arrow pointing downwards.	<p>PHOTO #2</p> <p>Overview – Fracturing at Field Membrane and evidence of ponding water</p>

RECOMMENDATIONS / SUMMARY
<p>Based on ACRC's observations and deficiencies overall this roof is of age and nearing the end of its Useful Roof Service Life. Due to the excessive amounts of blisters ACRC recommends not repairing this roof. This roof should be considered for a complete re-roof within the next year.</p>

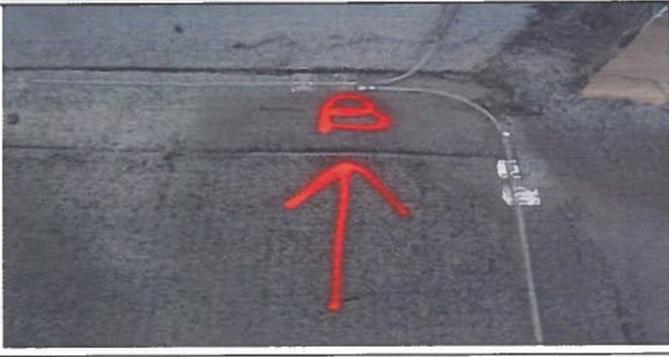
A photograph of a dark surface with a red letter "B" and a red arrow pointing upwards towards a specific area.	<p>PHOTO #3</p> <p>Blistering at Membrane Flashing and Lap</p>

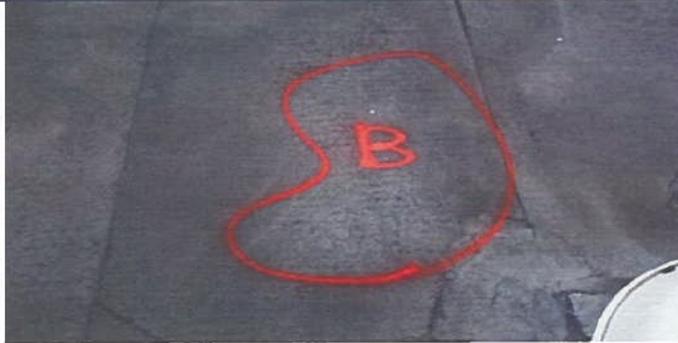
PHOTO #4

Blistering at Field Membrane

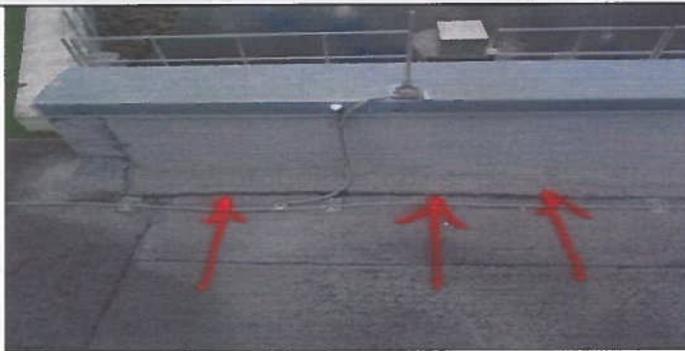
PHOTO #5

Blistering at Lap of Membrane Flashing

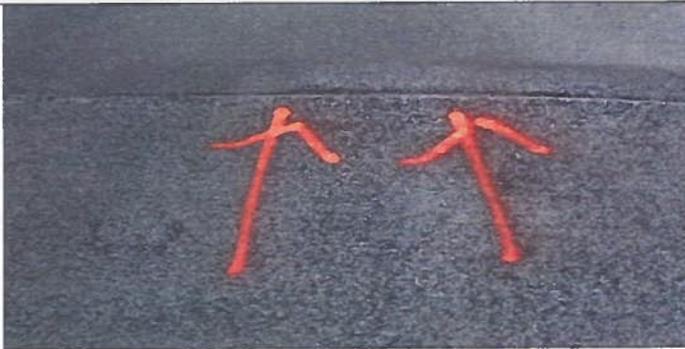
PHOTO #6

Blistering at Lap of Membrane Flashing

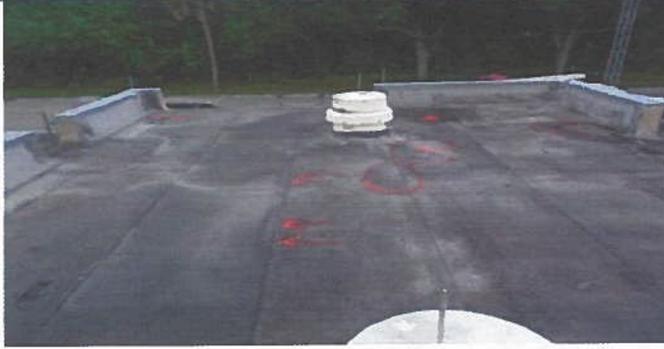
PHOTO #7

**Overview –
Roof and blistering**

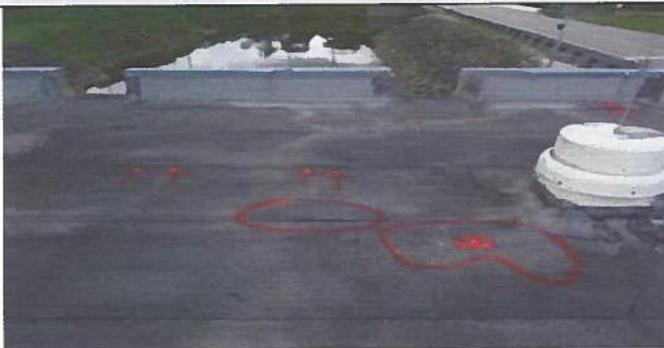
PHOTO #8

**Overview –
Roof and blistering**

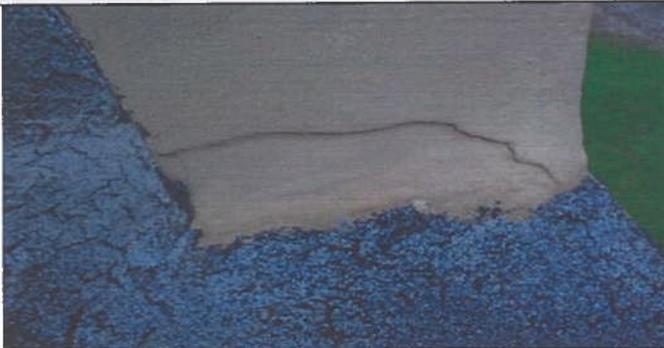
PHOTO #9

**Close-Up –
Crack at Parapet Wall**

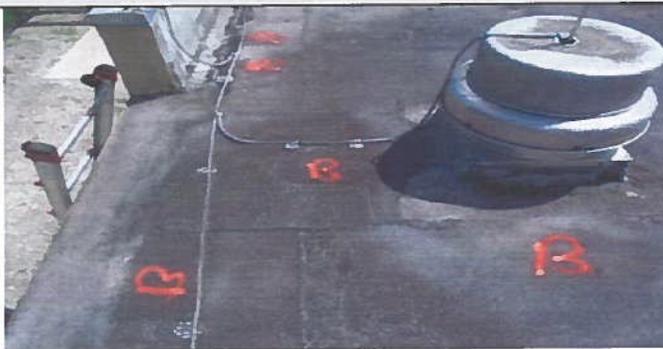
PHOTO #2

Overview – Blistering at Field Membrane

RECOMMENTATIONS / SUMMARY
<p>It's ACRC professional opinion that this roof system is near the end of its Useful Roof Service Life. ACRC does not recommend repairing this roof. This roof should be considered for a complete re-roof within the next.</p>

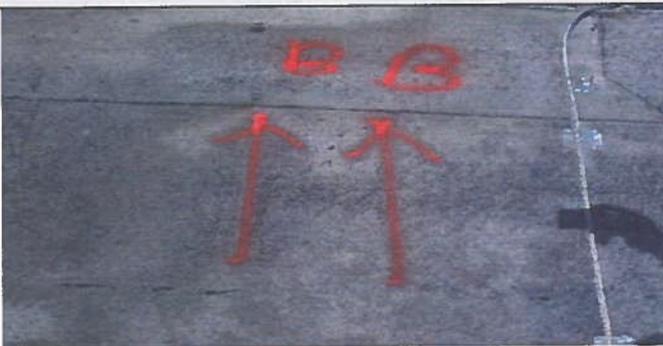
PHOTO #3

Close-Up – Blistering at laps of Field Membrane

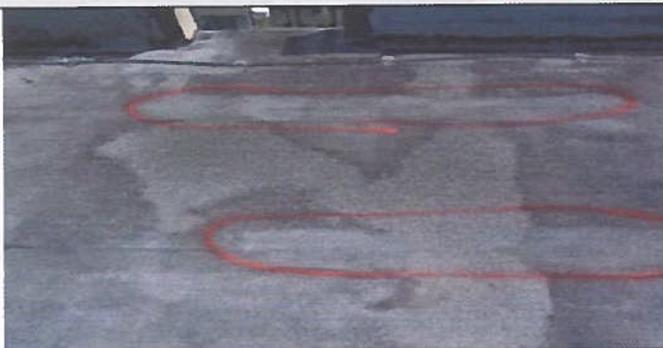
PHOTO #4

Repairs at Lap of Field Membrane

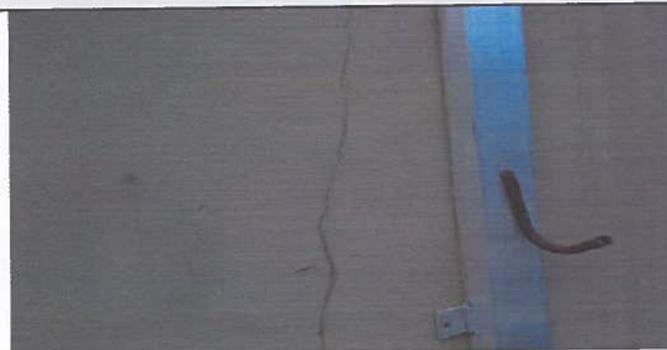
PHOTO #7

**Overview –
Hair-line crack at outside
wall near Downspout**
