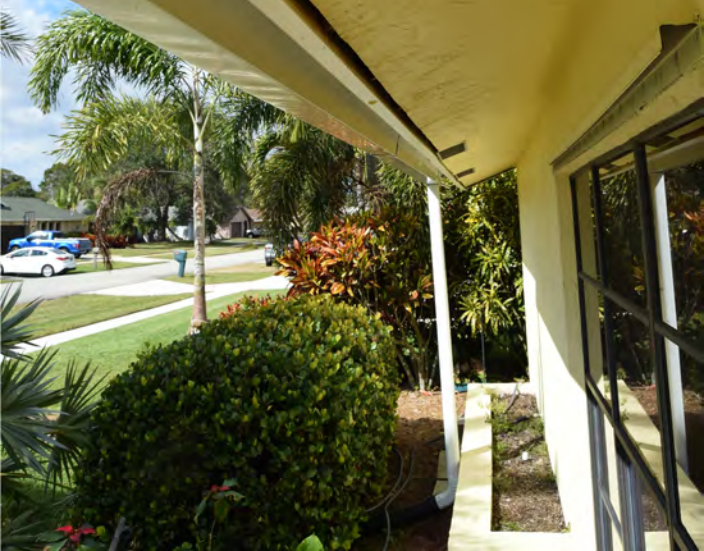
Eave not cut straight
or proper length, no
sealant between fascia
and eave.

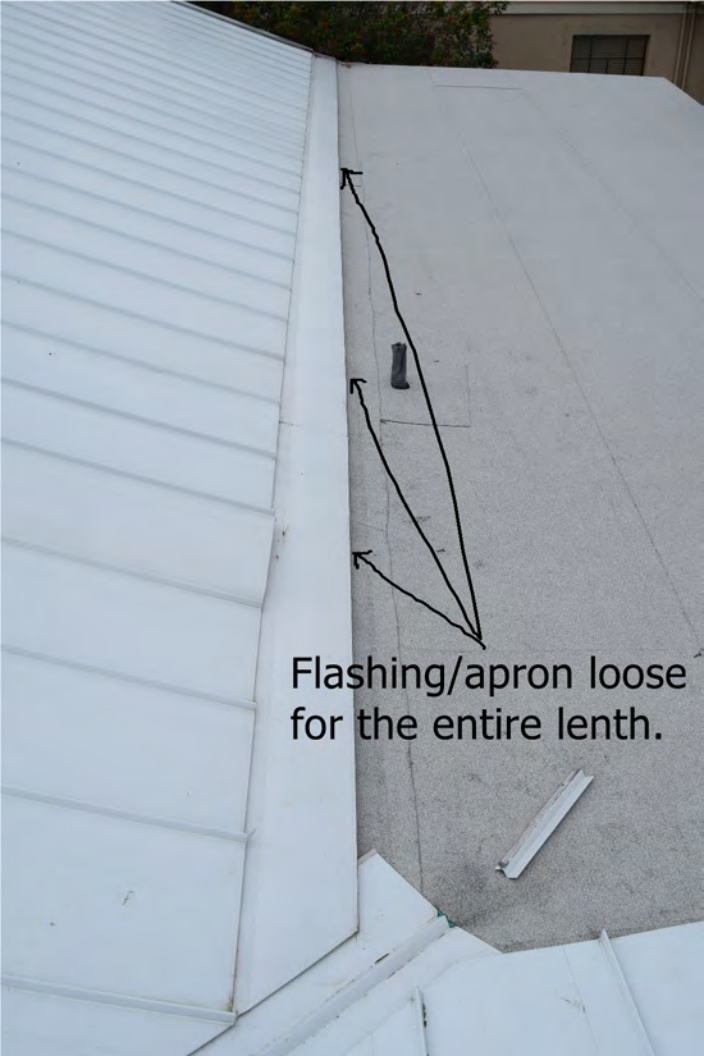
Flashing/apron loose
for the entire lenth.

Incorrect fascia installed (8")
should have been 10" per contract.
No space left for eave installation.

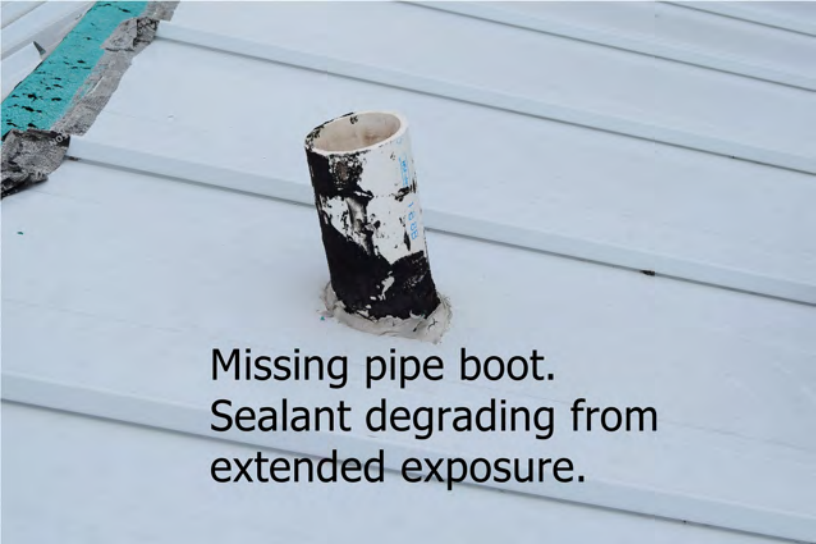
Missing pipe boot.
Sealant degrading from
extended exposure.

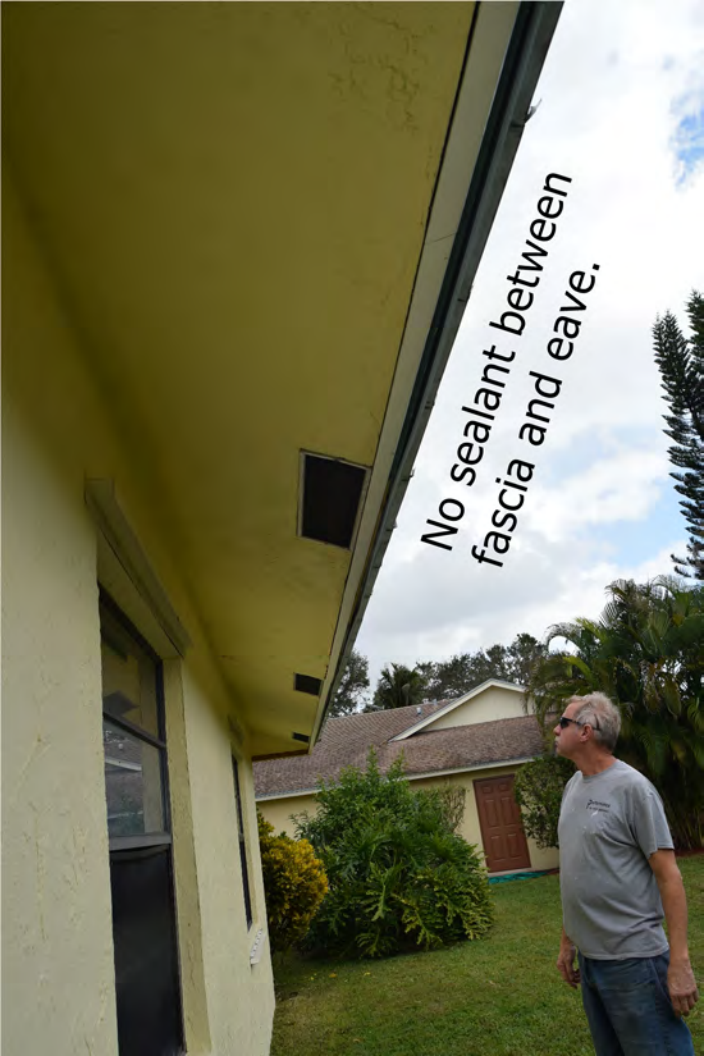
No sealant between
fascia and eave.

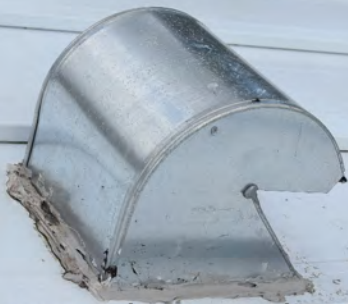
Improper sealant application.
Sealant degrading from
extended exposure.

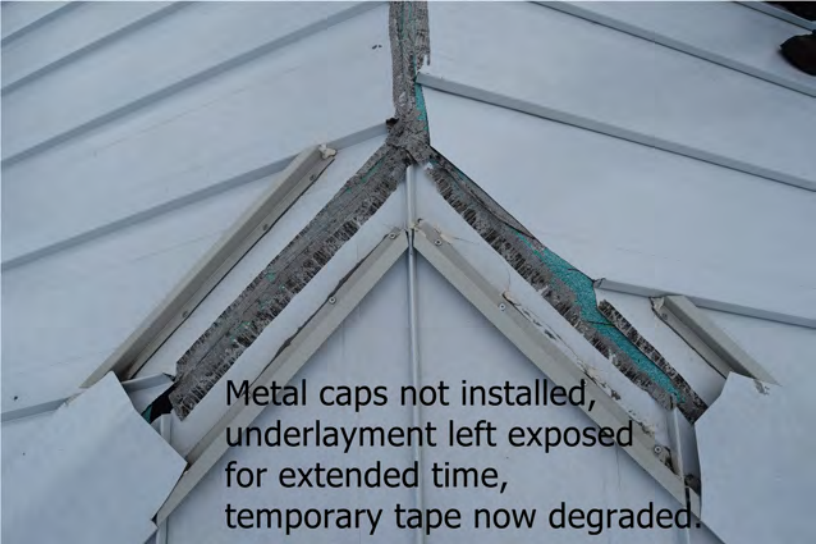
Metal caps not installed,
underlayment left exposed
for extended time,
temporary tape now degraded.

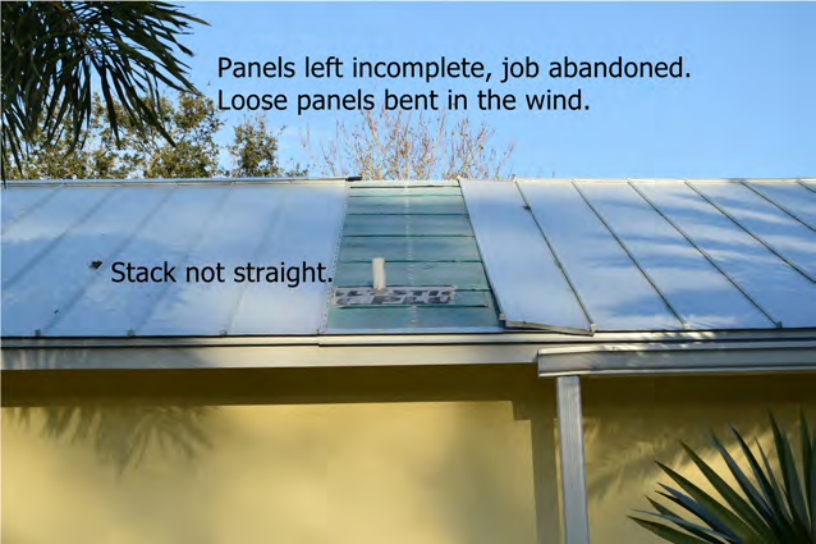
Stack not straight.

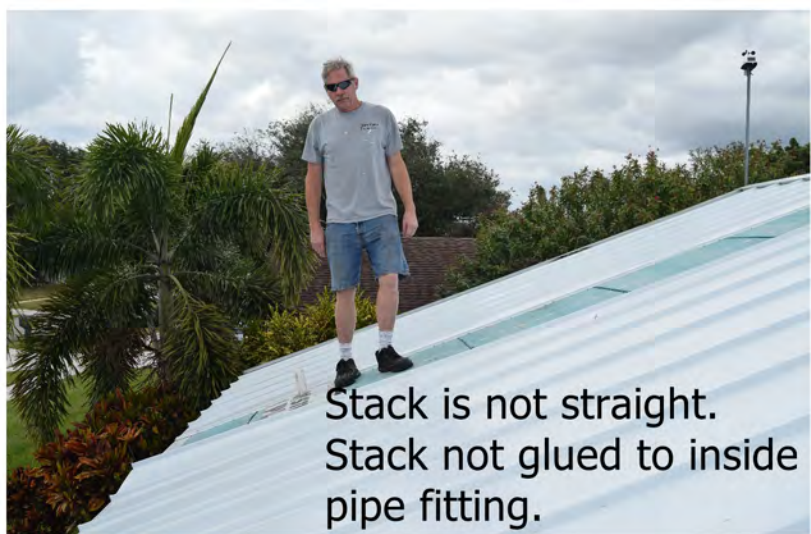
Stack is not straight.
Stack not glued to inside
pipe fitting.

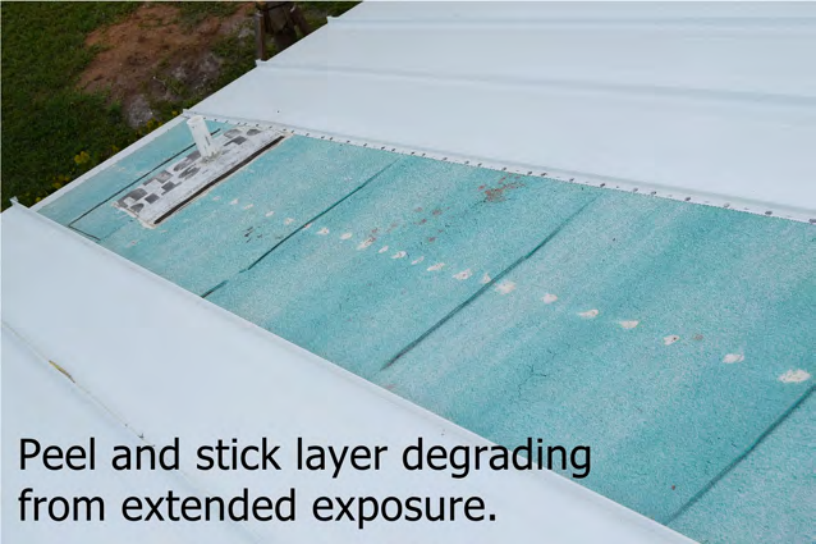
Peel and stick layer degrading
from extended exposure.

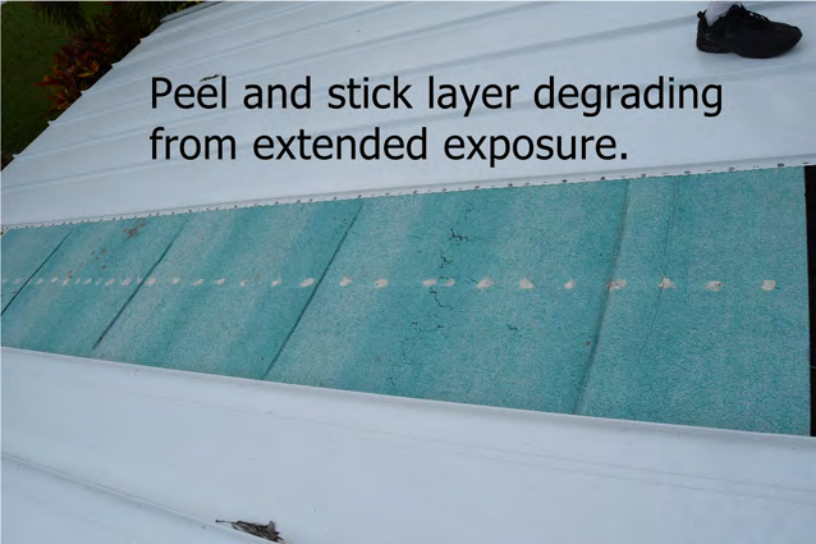
Peel and stick layer degrading
from extended exposure.

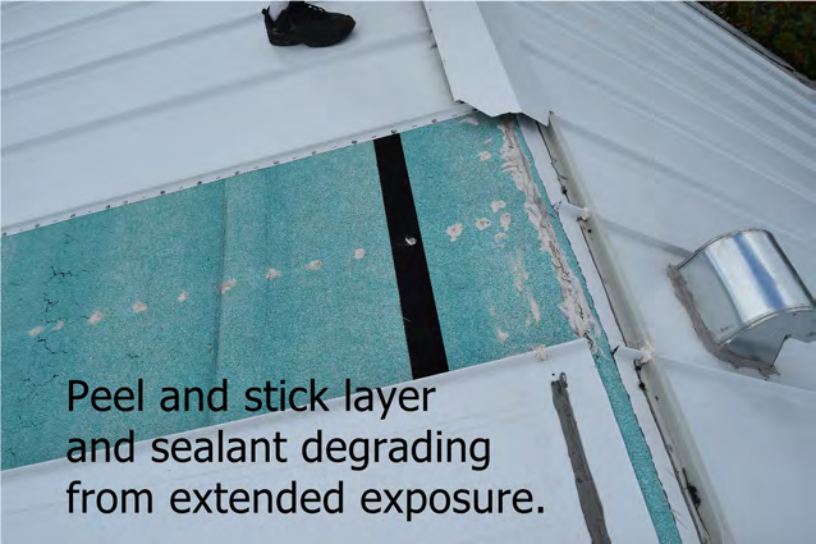
Peel and stick layer
and sealant degrading
from extended exposure.
