Neighborhood Reinvestment Project 1:

Sanitary Sewer Collection System Rehabilitation within SE Lake Wellington Area; White Pine & 12th Fairway, French Quarter, Sunset Point, Lakeshore Heights, Channing Villas & Park Place

SE Lake Wellington Area Water and Sewer Condition Assessment
Neighborhood Reinvestment Project 1:
White Pine & 12th Fairway

Proposed Sanitary Sewer Repairs

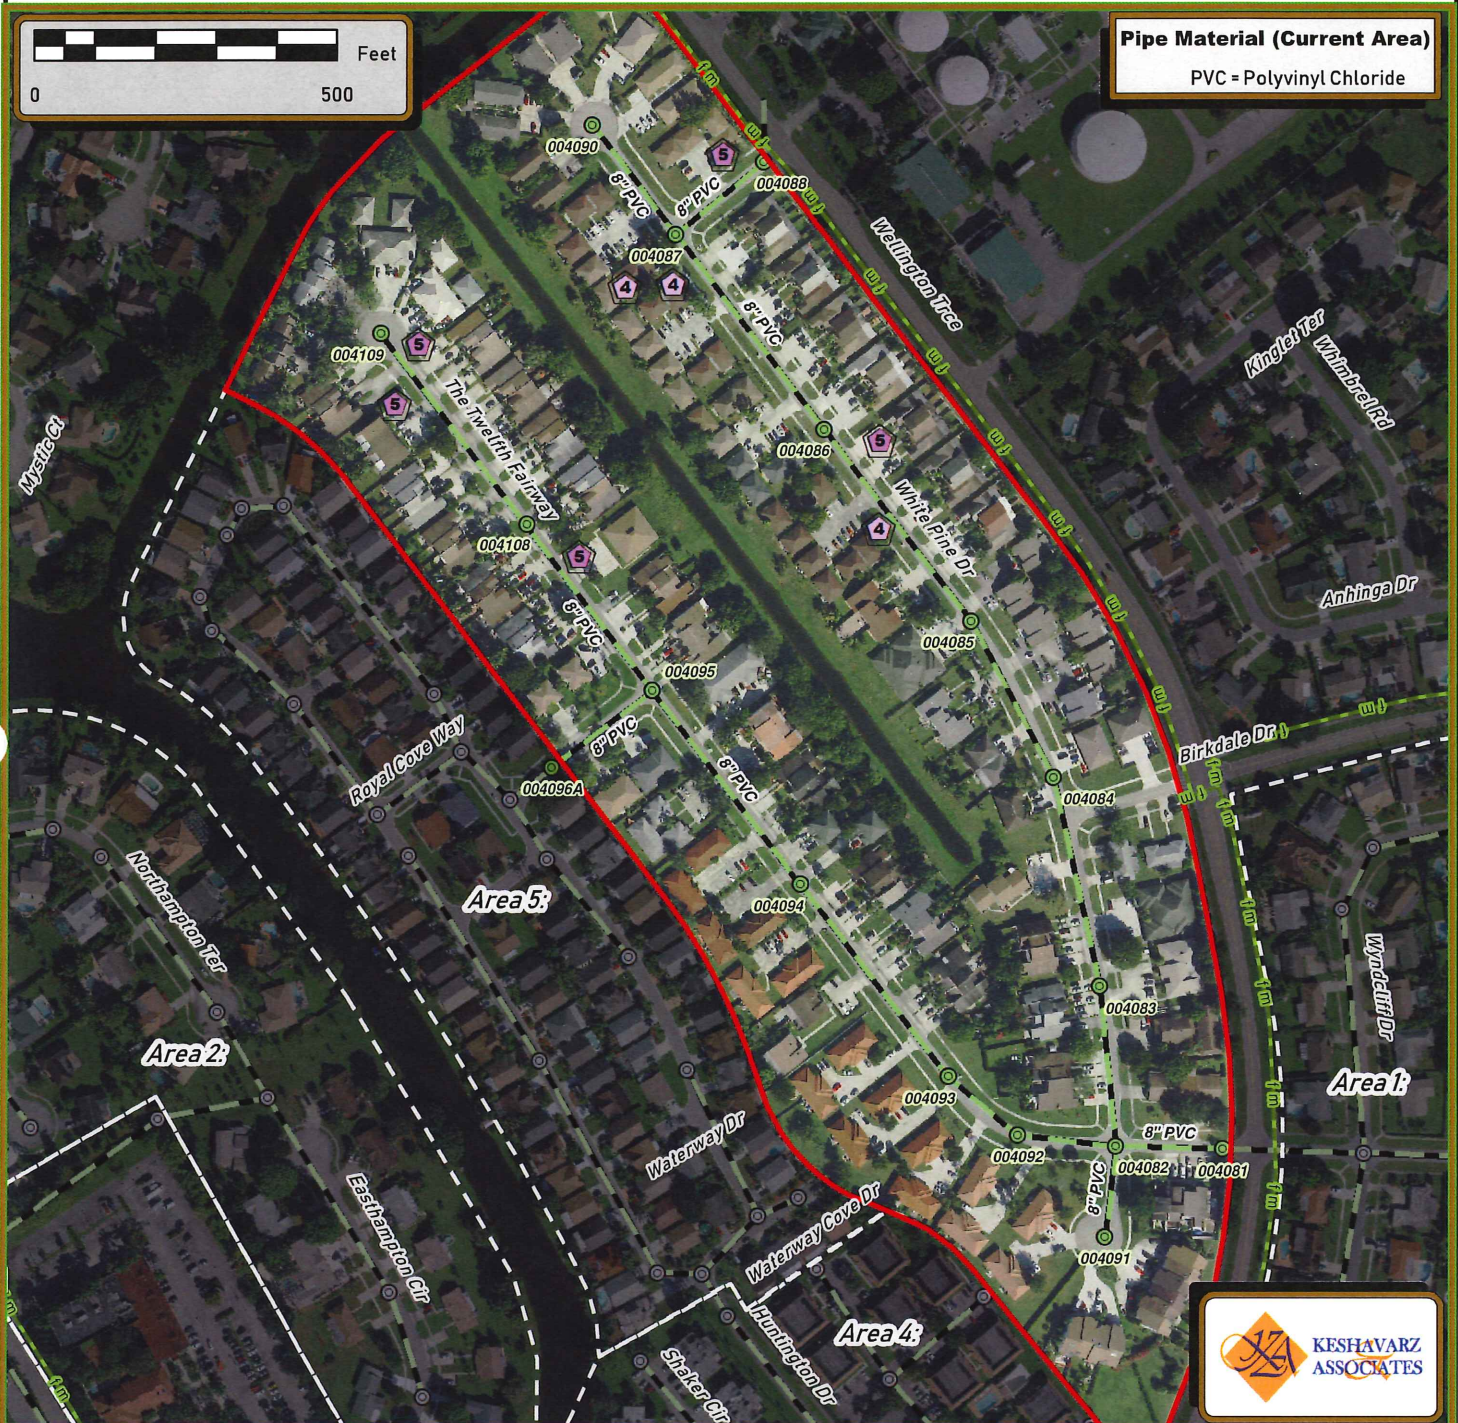
- The heavy solids within sewer main segment 004086-004085 should be mechanically removed.
- Service Laterals – Several of the service laterals that were inspected were found to have large amounts of grease and traces of sediments in laterals. Due to the high number of laterals observed with heavy grease, we are recommending to clean and video each of the service laterals within this area. Additional improvements such as lateral lining may be required once the laterals are cleaned and assessed. 64 service lateral repairs were included within the cost estimate for this project.

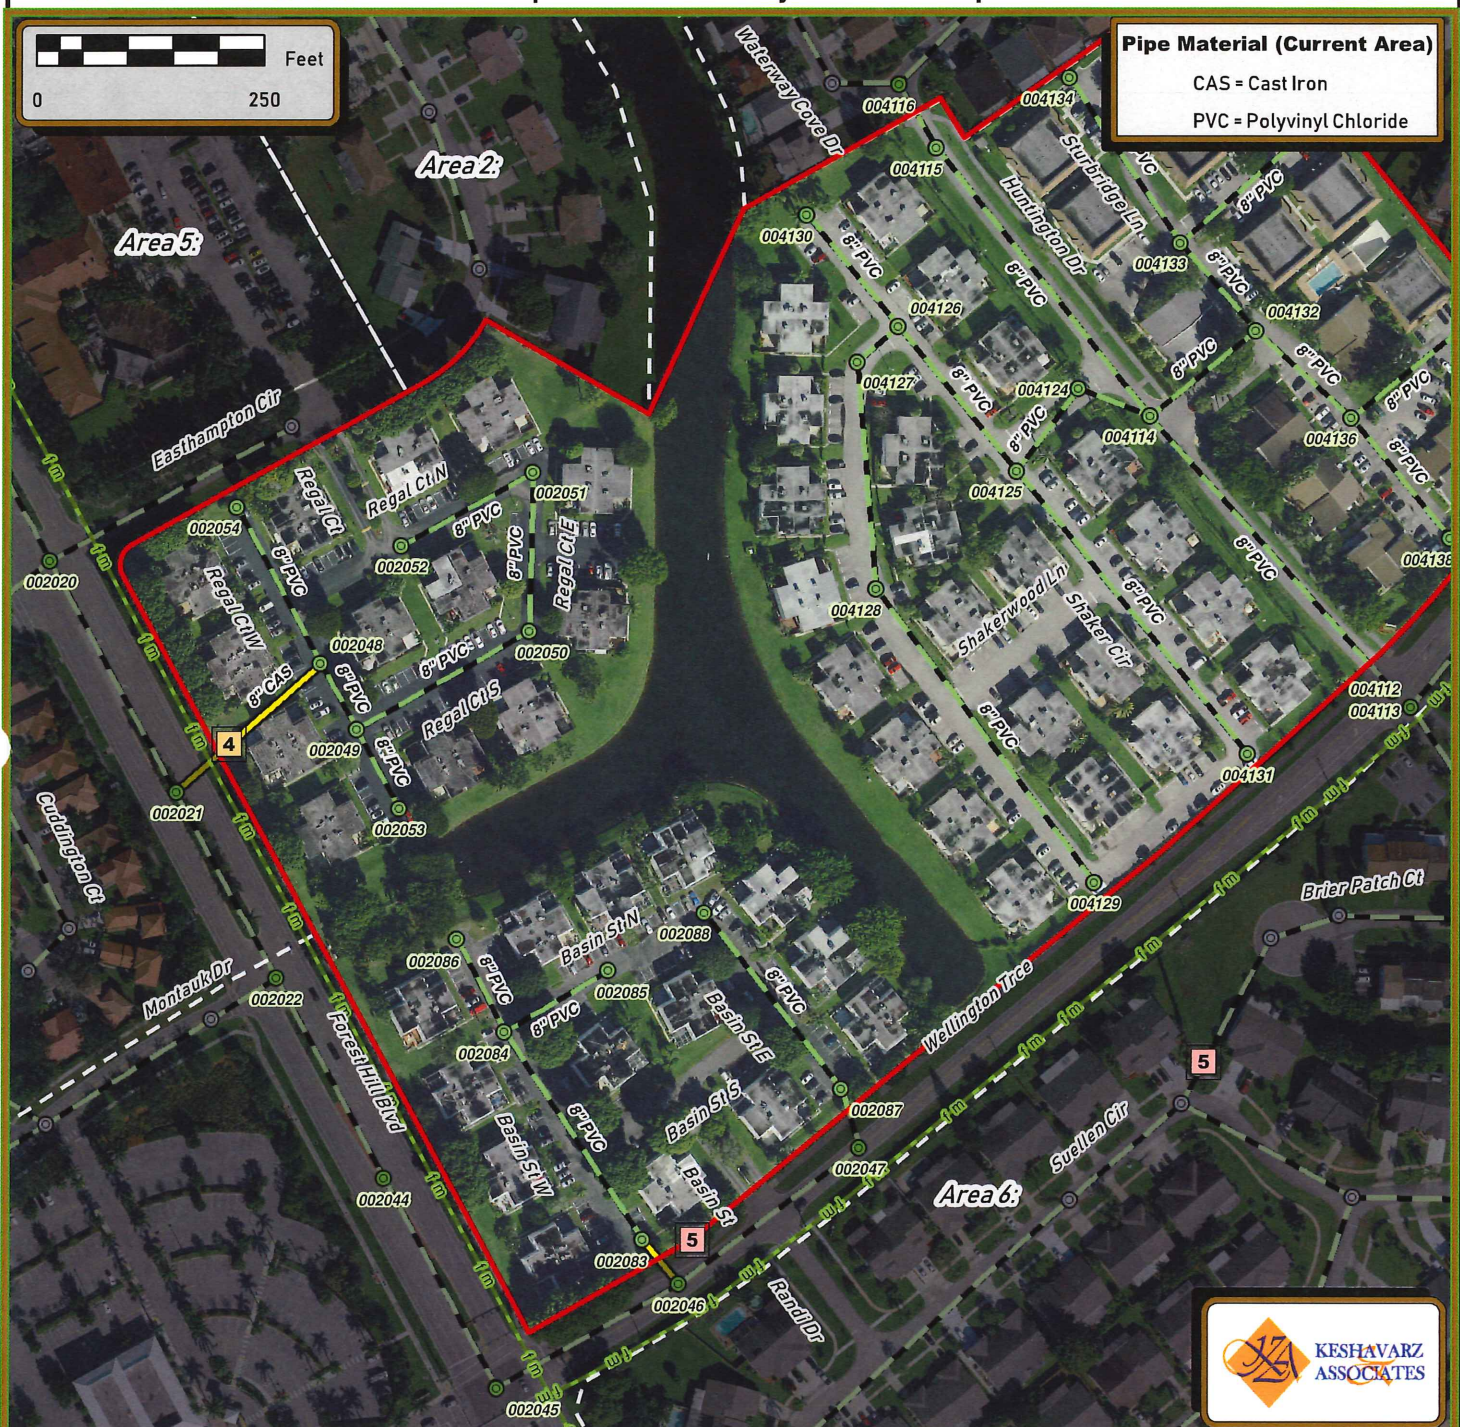
SE Lake Wellington Area Water and Sewer Condition Assessment
Neighborhood Reinvestment Project 1:
French Quarter

- The heavy tuberculation found within main segment 002048-002021 should be mechanically removed then the pipe segment should be lined with CIPP.
- The fracture / longitudinal crack found in the main should be repaired by CIPP, although the crack could easily be replaced with a spot repair, it appears to be located underneath an FP&L transformer and within the right-of-way of Wellington Trace.
- The ½" PVC pipe in the lateral protruding in the main should be mechanically removed.

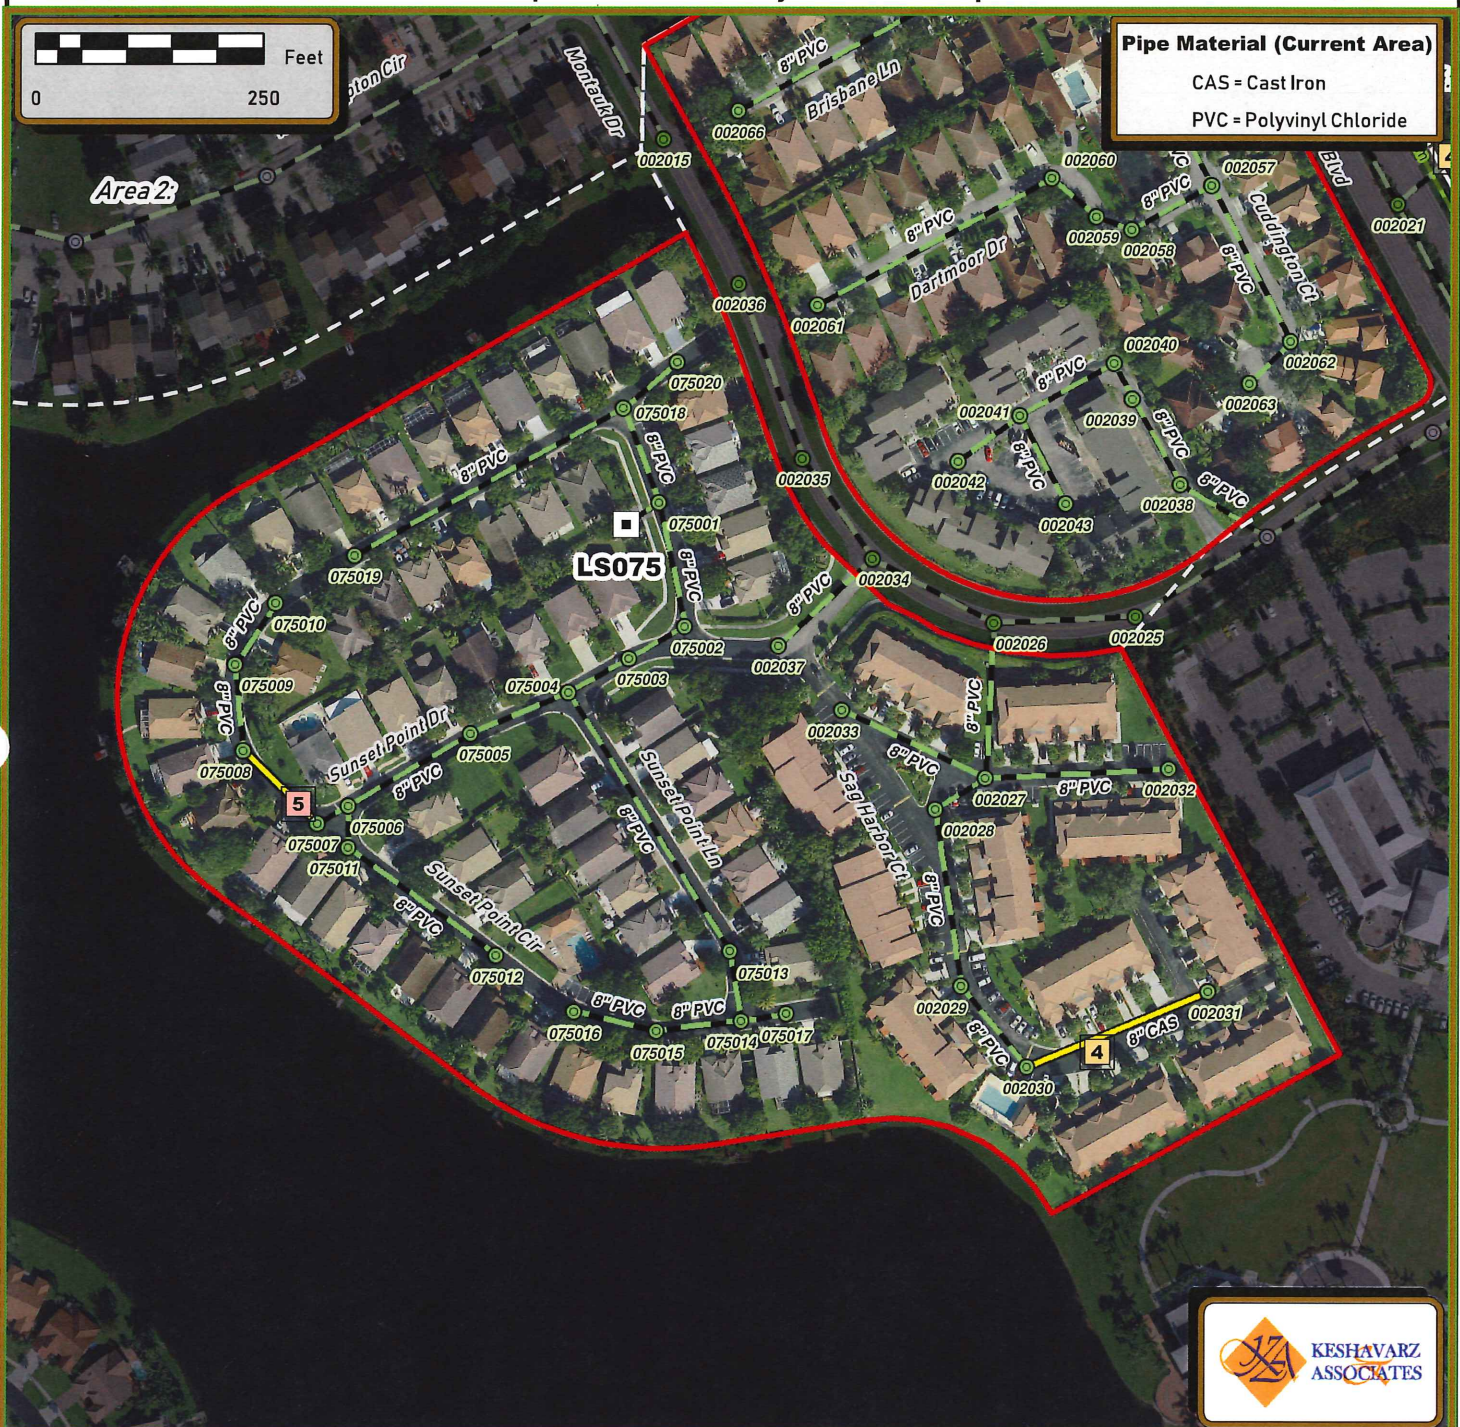
SE Lake Wellington Area Water and Sewer Condition Assessment
Neighborhood Reinvestment Project 1:
Sunset Point & Lakeshore Heights

- The tuberculation found within the 25' section of Cast Iron within main segment 075008-075007 should be mechanically removed then the Cast Iron portion of the segment should be lined with CIPP.

- The corroding DIP/CAS service wyes found with main segment 002031-002030 should be repaired by replacing the service wyes and laterals or CIPP lining of the mains and laterals. T-liners may be considered but need to be confirmed that they cover the entire limits of the corrosive materials with the main and the service wye.

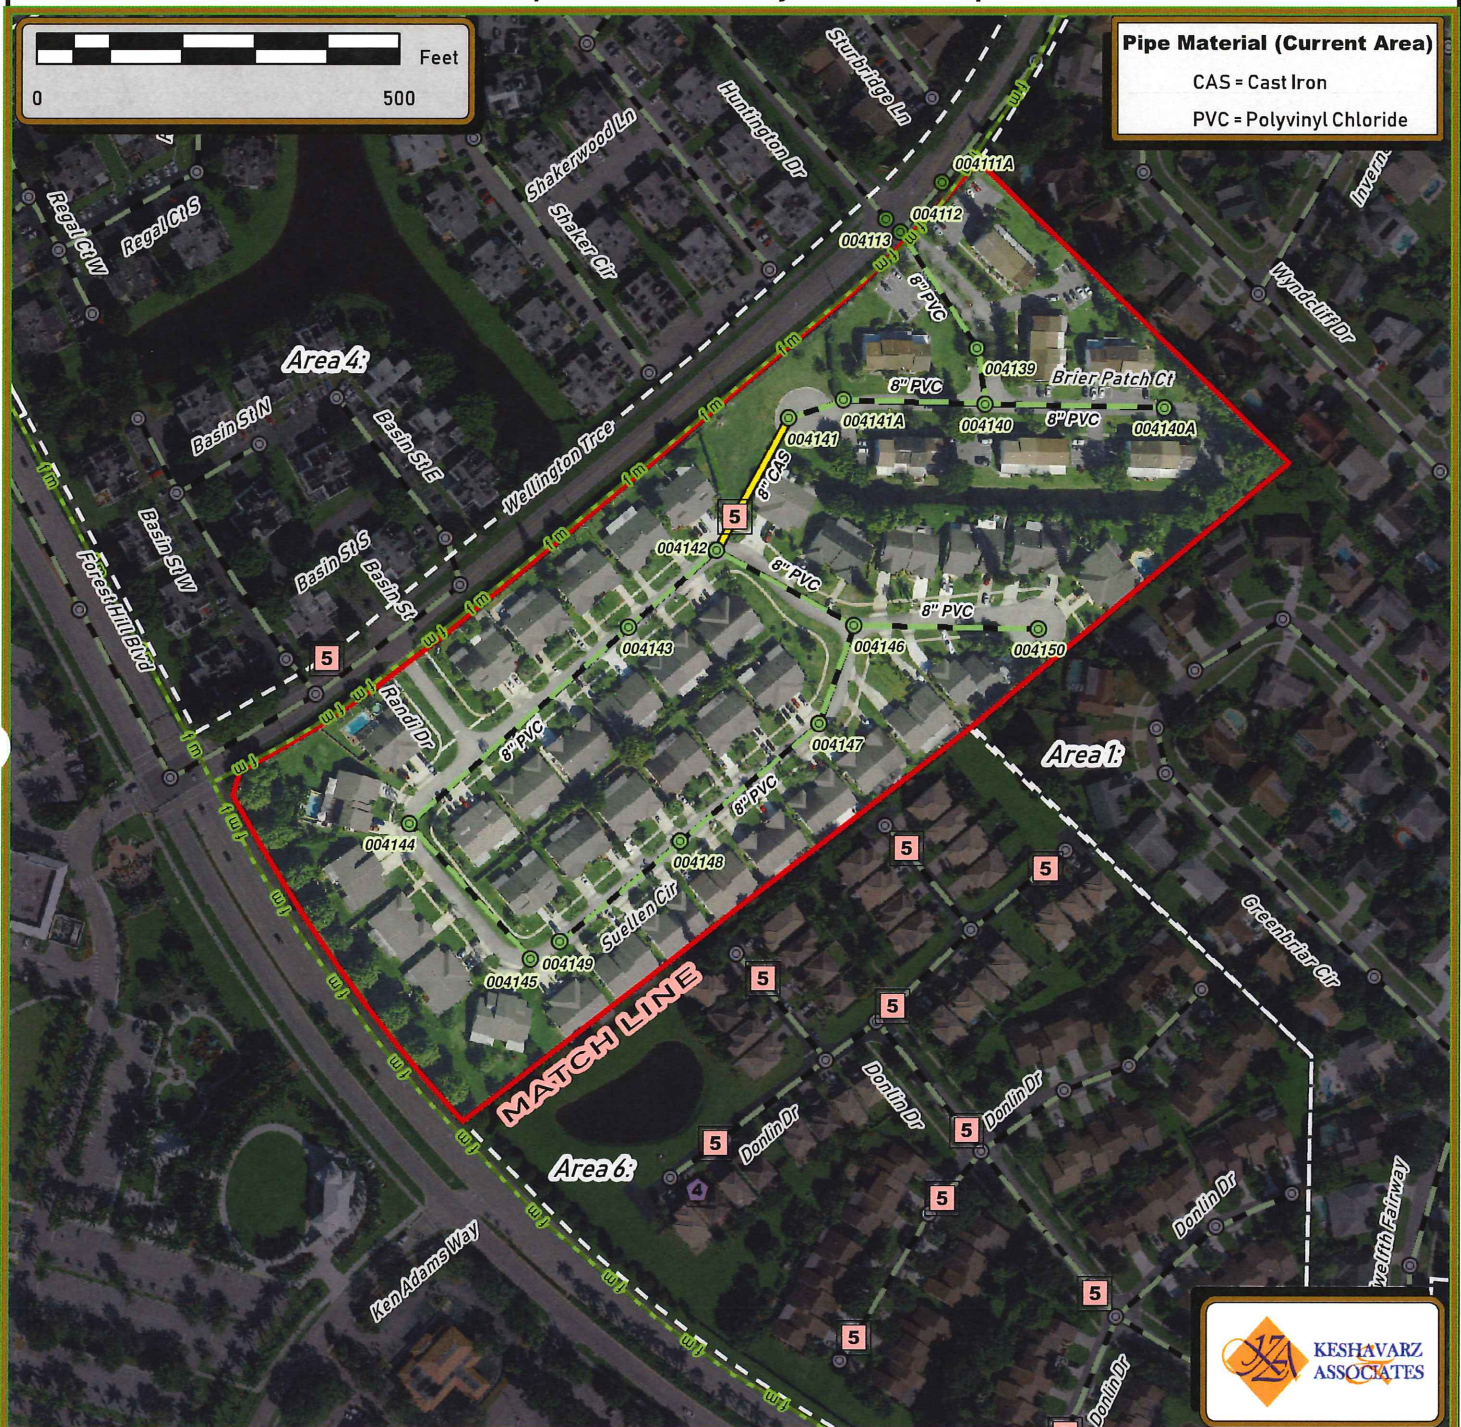
SE Lake Wellington Area Water and Sewer Condition Assessment
Neighborhood Reinvestment Project 1:
Channing Villas

- The heavy tuberculation found within main segment 004142-004141 should be mechanically removed then the pipe segment should be lined with CIPP.

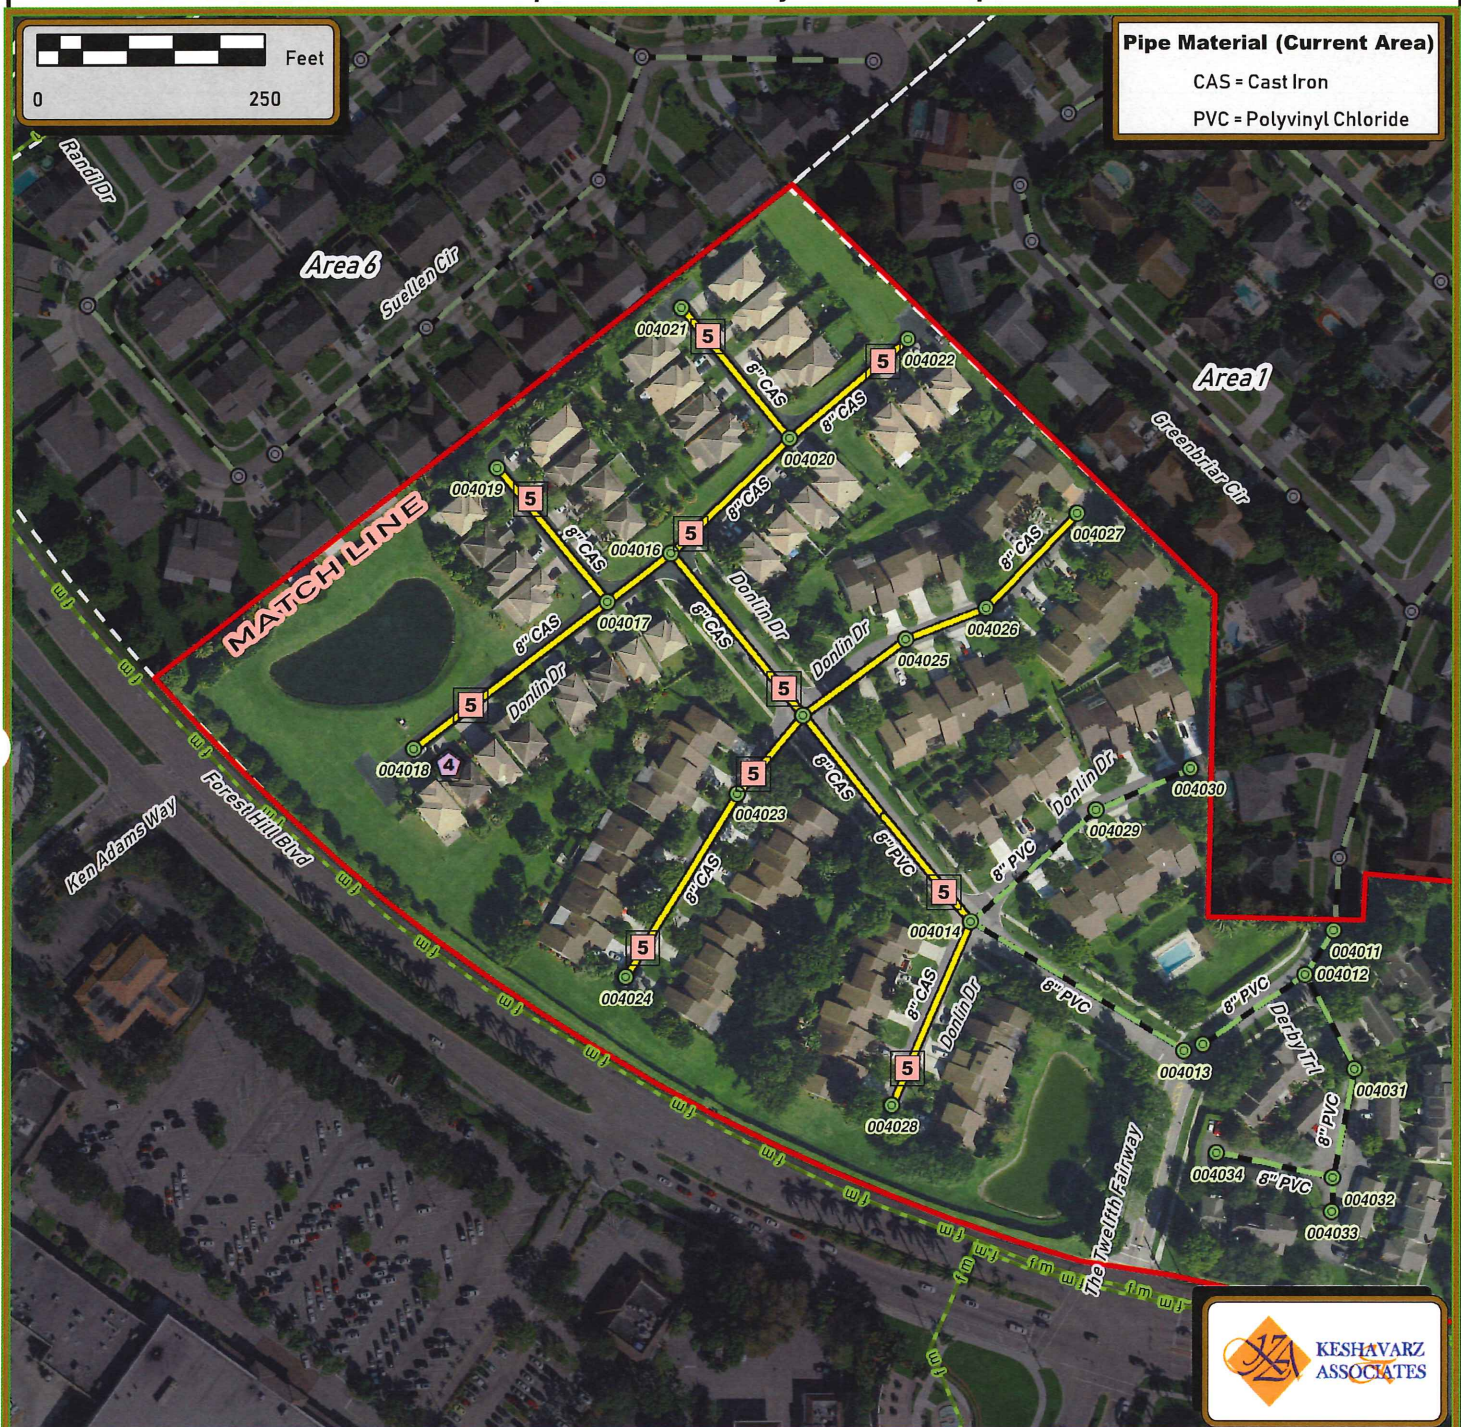
SE Lake Wellington Area Water and Sewer Condition Assessment
Neighborhood Reinvestment Project 1:
Park Place

- The DIP/CAS service wyes found to be corroding should be repaired by replacing the service wyes and laterals or CIPP lining of the mains and laterals. T-liners may be considered but need to be confirmed that they cover the entire limits of the corrosive materials with the main and the service wye.
- The lateral located at 11946 Donlin Drive should either be cleaned and lined or replaced. A cleanout will be installed at the right-of-way line.
