**ESTATES AT  
EQUESTRIAN VILLAGE**

**ENVIRONMENTAL ASSESSMENT REPORT**

**WELLINGTON EQUESTRIAN PARTNERS**

September 2022

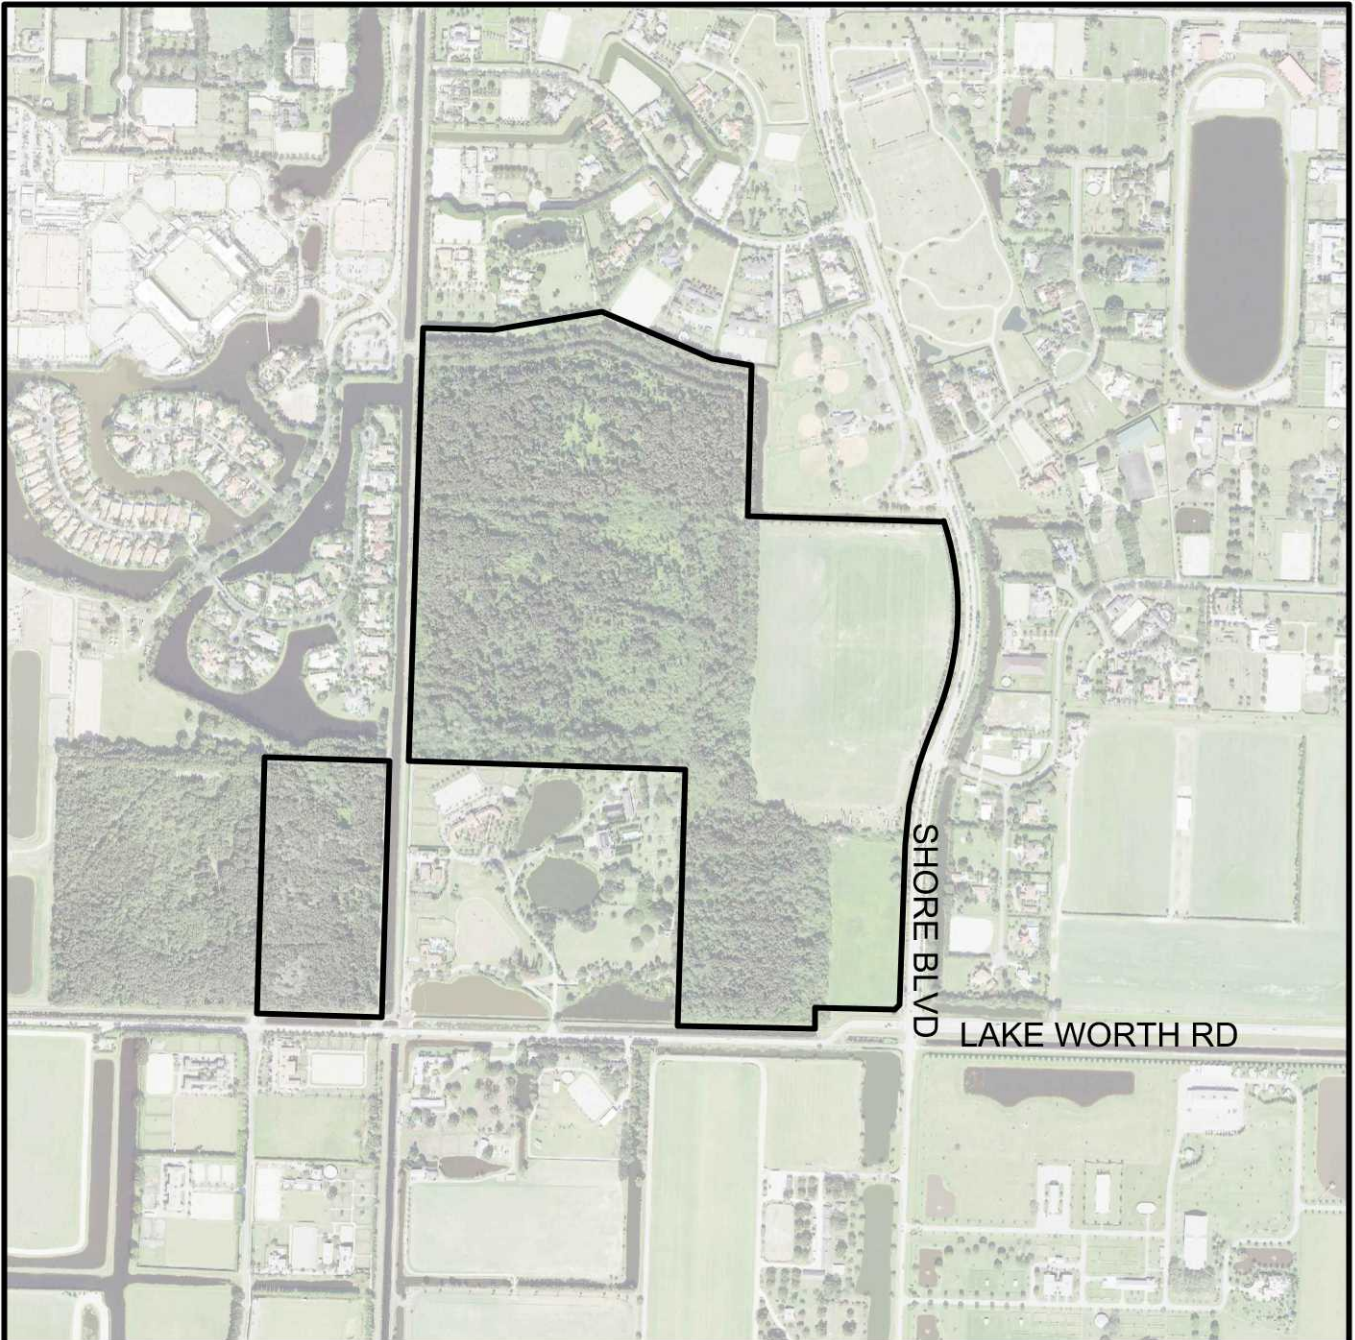
**3**

This Environmental Assessment Report documents and summarizes natural resource features present on a 175- acre project area in the Village of Wellington, Palm Beach County. The project area is comprised of a main site and an amenities parcel to the southwest, west of the C-4 Canal. The main site is bordered to the north by a residential single family home neighborhood and a community park; to the west by the ACME C-4 Canal; to the east generally by Southshore Boulevard; and to the south by 40<sup>th</sup> Street/Lake Worth Road and the adjacent C-24 Canal. The site is situated within Sections 20 and 21, Township 44 South, Range 41 East; Palm Beach County, Florida. A Location Map (Figure 1), USGS Quad Map (Figure 2), and Aerial Photo (Figure 3) depicting the site boundaries and immediate surrounding areas are provided in the Appendix.

PALM BEACH COUNTY AERIAL DATED 2022

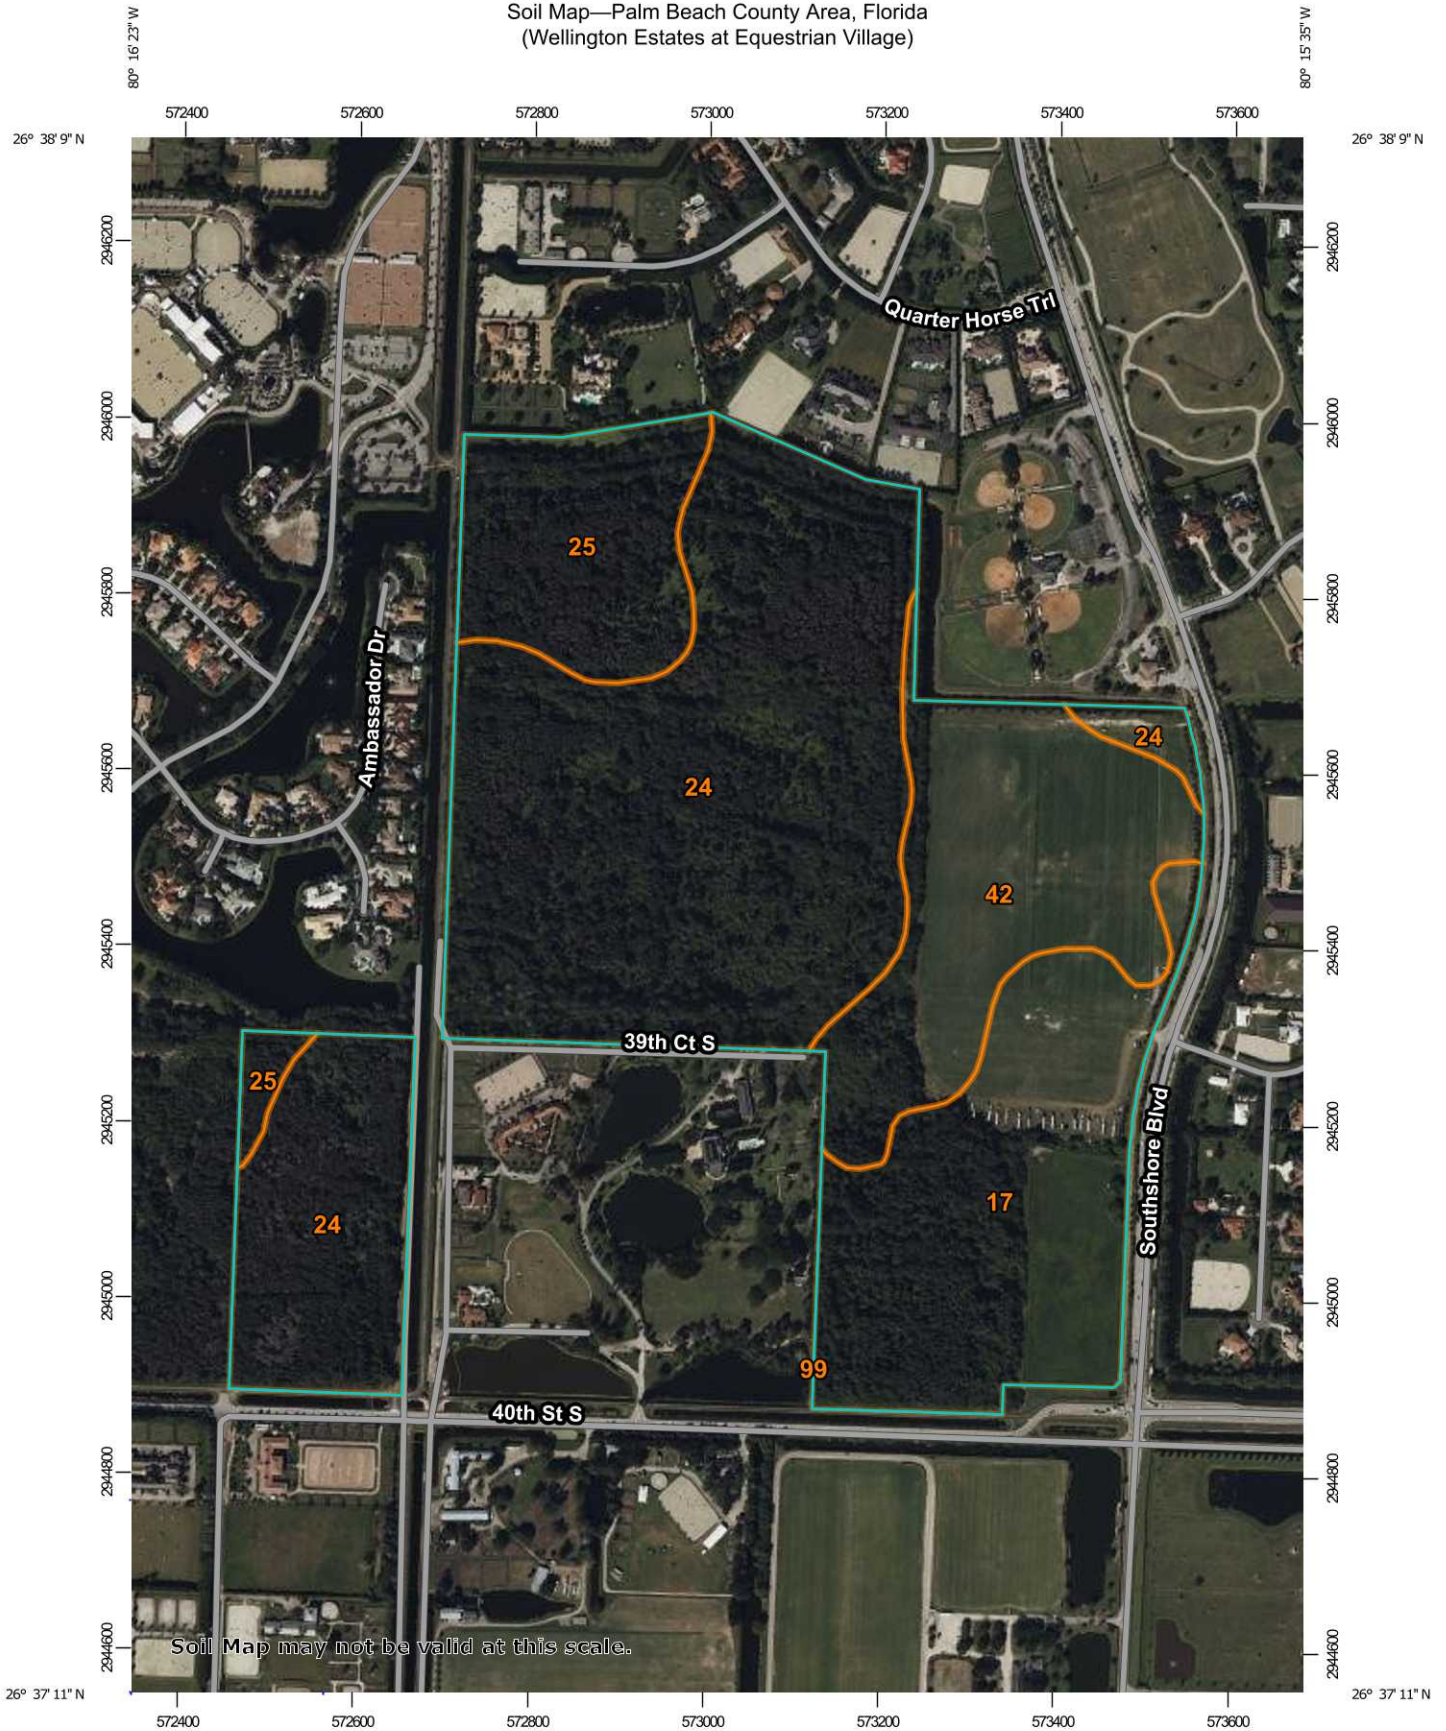
Soil Map—Palm Beach County Area, Florida  
(Wellington Estates at Equestrian Village)

The soil on the site is mapped as Riviera fine sand, frequently ponded, 0 to 1 percent slopes, and Riviera fine sand, frequently ponded (depressional), 0 to 2 percent slopes. A description of each soil type in its natural condition is listed below. The description is based upon the general characteristics for the soil type as illustrated in the Soils Survey of Palm Beach County Area, Florida and is not necessarily indicative of the exact characteristics of the parcels. A soils map with the site boundary is included in the Appendix as an attachment.

Map Unit Symbol	Map Unit Name	Acres in AOI	Percent of AOI
17	Holopaw fine sand, 0 to 2 percent slopes	36.9	21.0%
24	Okeelanta muck, drained, frequently ponded, 0 to 1 percent slopes	90.0	51.2%
25	Oldsmar sand, 0 to 2 percent slopes	19.0	10.8%
42	Tequesta muck, frequently ponded, 0 to 1 percent slopes	29.9	17.0%
99	Water	0.0	0.0%
<b>Totals for Area of Interest</b>		<b>175.7</b>	<b>100.0%</b>

Halopaw fine sand, 0 to 2 percent slopes (17). This is a nearly level, poorly drained soil that has a thick sandy surface layer and loamy subsoil at a depth of 40 to 72 inches. This soil is on broad low-lying flats and depressions. Under natural conditions the water table is within 10 inches of the surface for 2 to 6 months during most years. Depressions are covered by water for 6 months or more in most years. The typical natural vegetation is saw-palmetto, slash pine, cypress, cabbage palm, inkberry, southern bayberry, sand cordgrass, broomsedge bluestem, blue maidencane, pineland three-awn, and other grasses.

Okeelanta muck, drained, frequently ponded, 0 to 1 percent slopes (24) – This is a poorly drained, organic soil that has sandy mineral material within a depth of 40 inches. It is in large, fresh water marshes and small, isolated depressions. Under natural conditions, the soil is covered

Oldsmar sand, 0 to 2 percent slopes (25) – This is a nearly level, poorly drained, sandy soil that has a dark colored, weakly cemented layer below a depth of 30 inches over a loamy layer. It is in broad, flatwood areas. Under natural conditions the water table is within 10 inches of the surface for 1 to 3 months during most years. It is within 10 to 40 inches for 6 or more months in most years and recedes to below 40 inches in extended dry periods. The typical natural vegetation is saw-palmetto, slash pine, cabbage palm, inkberry, southern bayberry, pineland three-awn, blue maidencane, fetterbush, broomsedge, bluestem, and a variety of other grasses.

Tequesta muck, frequently ponded, 0 to 1 percent slopes (42) – This is a nearly level, very poorly drained soil that has a thin organic layer on the surface overlying a mineral soil that has a sandy surface layer and a loamy subsoil. This soil is on broad, low flats and in marshes and depressions. Under natural conditions, this soil is covered by water for 4 to 6 months in most years. The water table is within 10 inches of the surface for 6 to 12 months during most years. The typical natural vegetation is needlegrass, pickerelweed, maidencane, ferns, southern bayberry, and scattered cypress trees.
