**ESTATES AT
EQUESTRIAN VILLAGE**

ENVIRONMENTAL ASSESSMENT REPORT

WELLINGTON EQUESTRIAN PARTNERS

September 2022

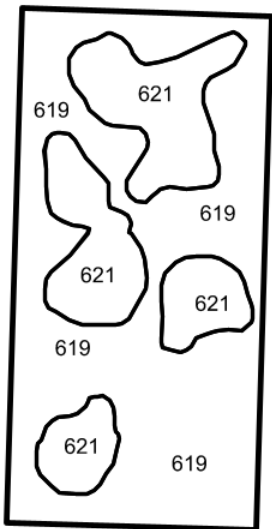
SEPT 2022
FIGURE 4

Field reconnaissance and aerial photograph interpretation were employed in the mapping effort of the vegetative communities on the project area. The vegetative community descriptions include discussions of potential wildlife habitat in those communities. A land cover map of the observed community types with acreage is included as Figure 4 in the Appendix of this report.

- LEGEND**
- 189 - OTHER RECREATIONAL (36.5± AC)
 - 212 - UNIMPROVED PASTURE (8.1± AC)
 - 510 - DITCHES (2.5± AC)
 - 619 - EXOTIC WETLAND HARDWOODS (115.8± AC)
 - 621 - CYPRESS (6.3± AC)
 - 743 - SPOIL AREAS (6.6± AC)
 - TOTAL SITE (175.8± AC)**

189 Recreational-Equestrian – 36.5 acres this land area comprises a large portion of the northeastern corner of the subject property. It is a grassed area that exhibits prior grading and regular maintenance as an equestrian practice field.

212 Unimproved Pasture –8.1 acres this area is previously cleared land with some stands of trees and brush where grasses and weeds have been allowed to develop. Generally unmanaged but occasionally mowed in the majority of the area. Vegetation coverage is Bahia grass, ruderal weeds, shrubby false buttonweed, caesar weed, and some primrose willow and small Brazilian pepper.

510 Ditches – 2.5 acres This land use is found in several areas of the property. The ditches run east-west and north-south on the subject parcel. The vegetative assembly is dominated by invasive species such as cattail, torpedo grass, primrose willow and Brazilian pepper.

619 Exotic Wetland Hardwoods – 115.8 acres this disturbed land area comprises the largest portion of the subject property and includes the impoundment. The majority of the canopy and subcanopy vegetation is dominated by melaleuca, Brazilian pepper, Java plum, Carolina willow, bishop wood, woman's tongue, earleaf acacia, air potato and lygodium. Sparse native vegetation is found in areas with groundcover and includes cattails, chain fern, and swamp fern.

621 Cypress –6.3 acres this habitat is found within the amenities portion of the subject property west of the canal and north of Lake Worth Road. These areas are presently poor quality cypress swamp wetlands with a canopy of cypress and predominant subcanopy of Brazilian pepper and Japanese climbing fern, with scattered swamp fern and chain fern.

743 Disturbed Lands-Spoil Areas-Berm – 6.6 acres this land use comprises a large encircling berm around the impoundment portion of the property, and another smaller section along the north boundary of the C-24 Canal Lake Worth Road. Vegetation coverage on the berm includes mainly Brazilian pepper with scattered oaks, eucalyptus, and some ornamental trees.
