# Wellington Broadview

## ENVIRONMENTAL ASSESSMENT REPORT

October 2022

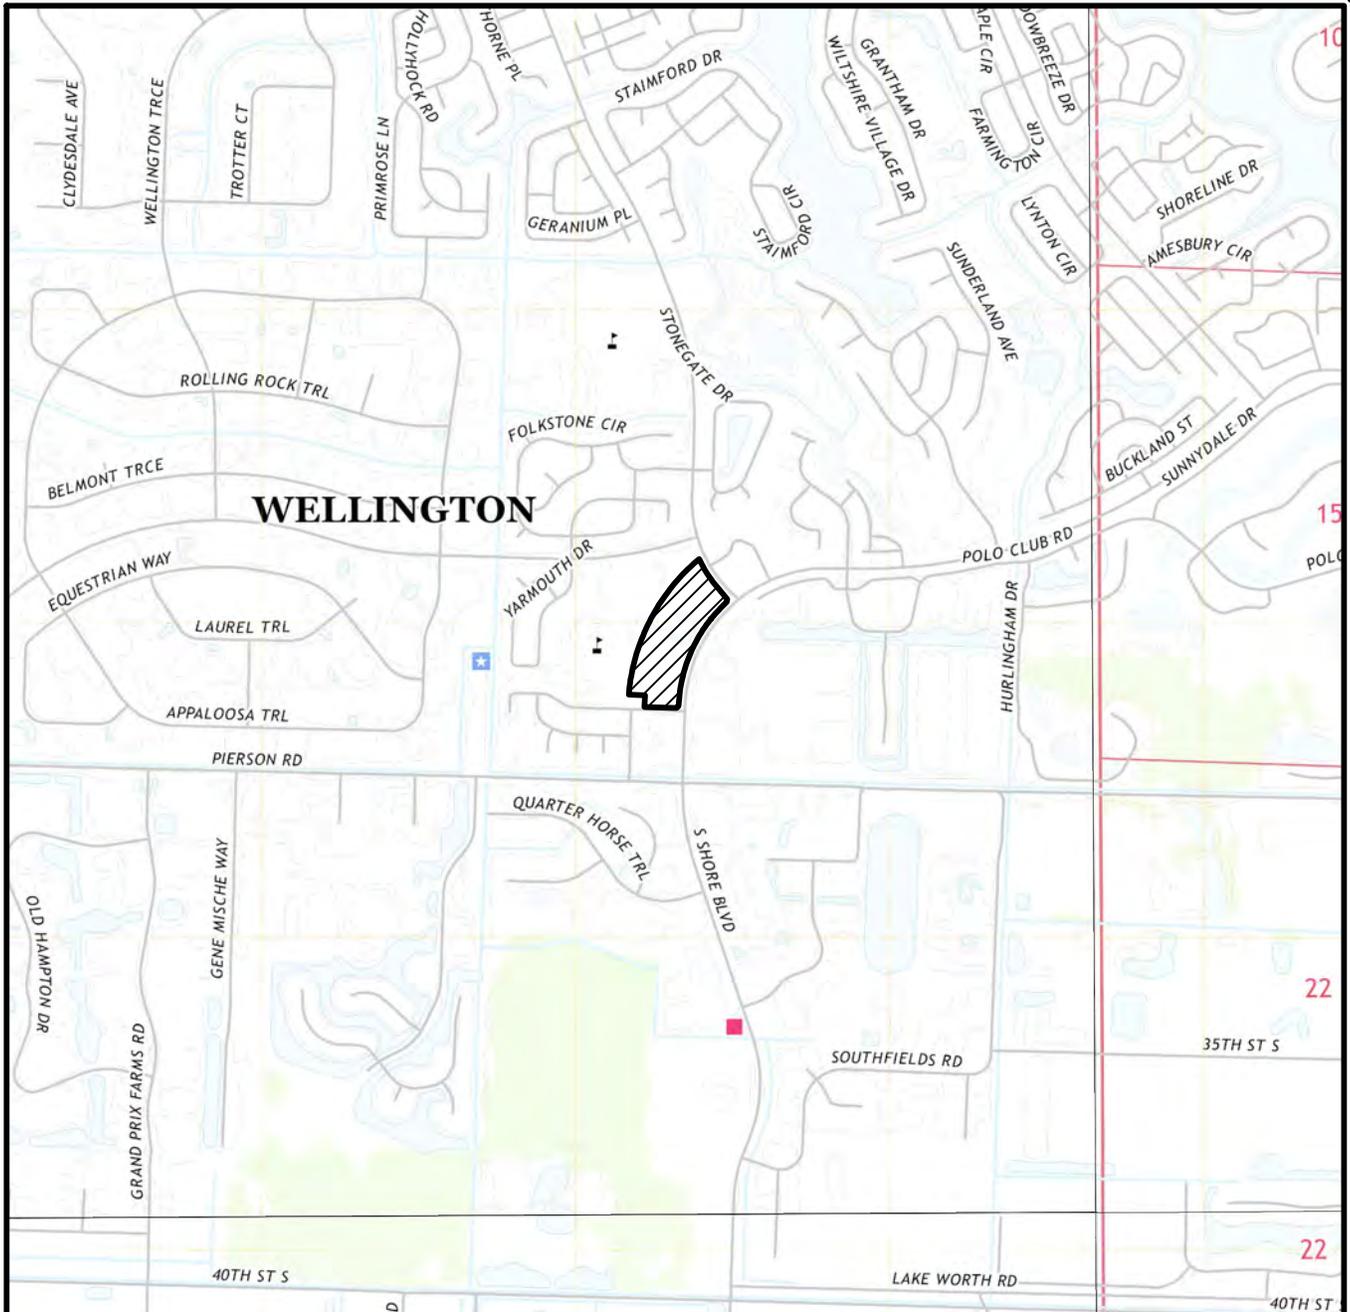
**2**

USGS QUAD MAPS "LOXAHATCHEE", TOWNSHIP 44 SOUTH, RANGE 41 EAST, VILLAGE OF WELLINGTON, PALM BEACH COUNTY, FLORIDA, LATITUDE 26°38'30" LONGITUDE -80°15'48"

Prior to the site visit, the U.S. Geological Survey 7.5-minute Quadrangle Topographic Map, Loxahatchee SE and Loxahatchee Quadrangles, and the *Soils Survey of Palm Beach County Area, Florida* (U.S. Department of Agriculture, Soil Conservation Service 1970) were reviewed to determine topographic features and site soil mapping units. Copies of the 2022 Palm Beach County aerial photographs of the parcels were obtained and reviewed to determine potential locations of environmental features.

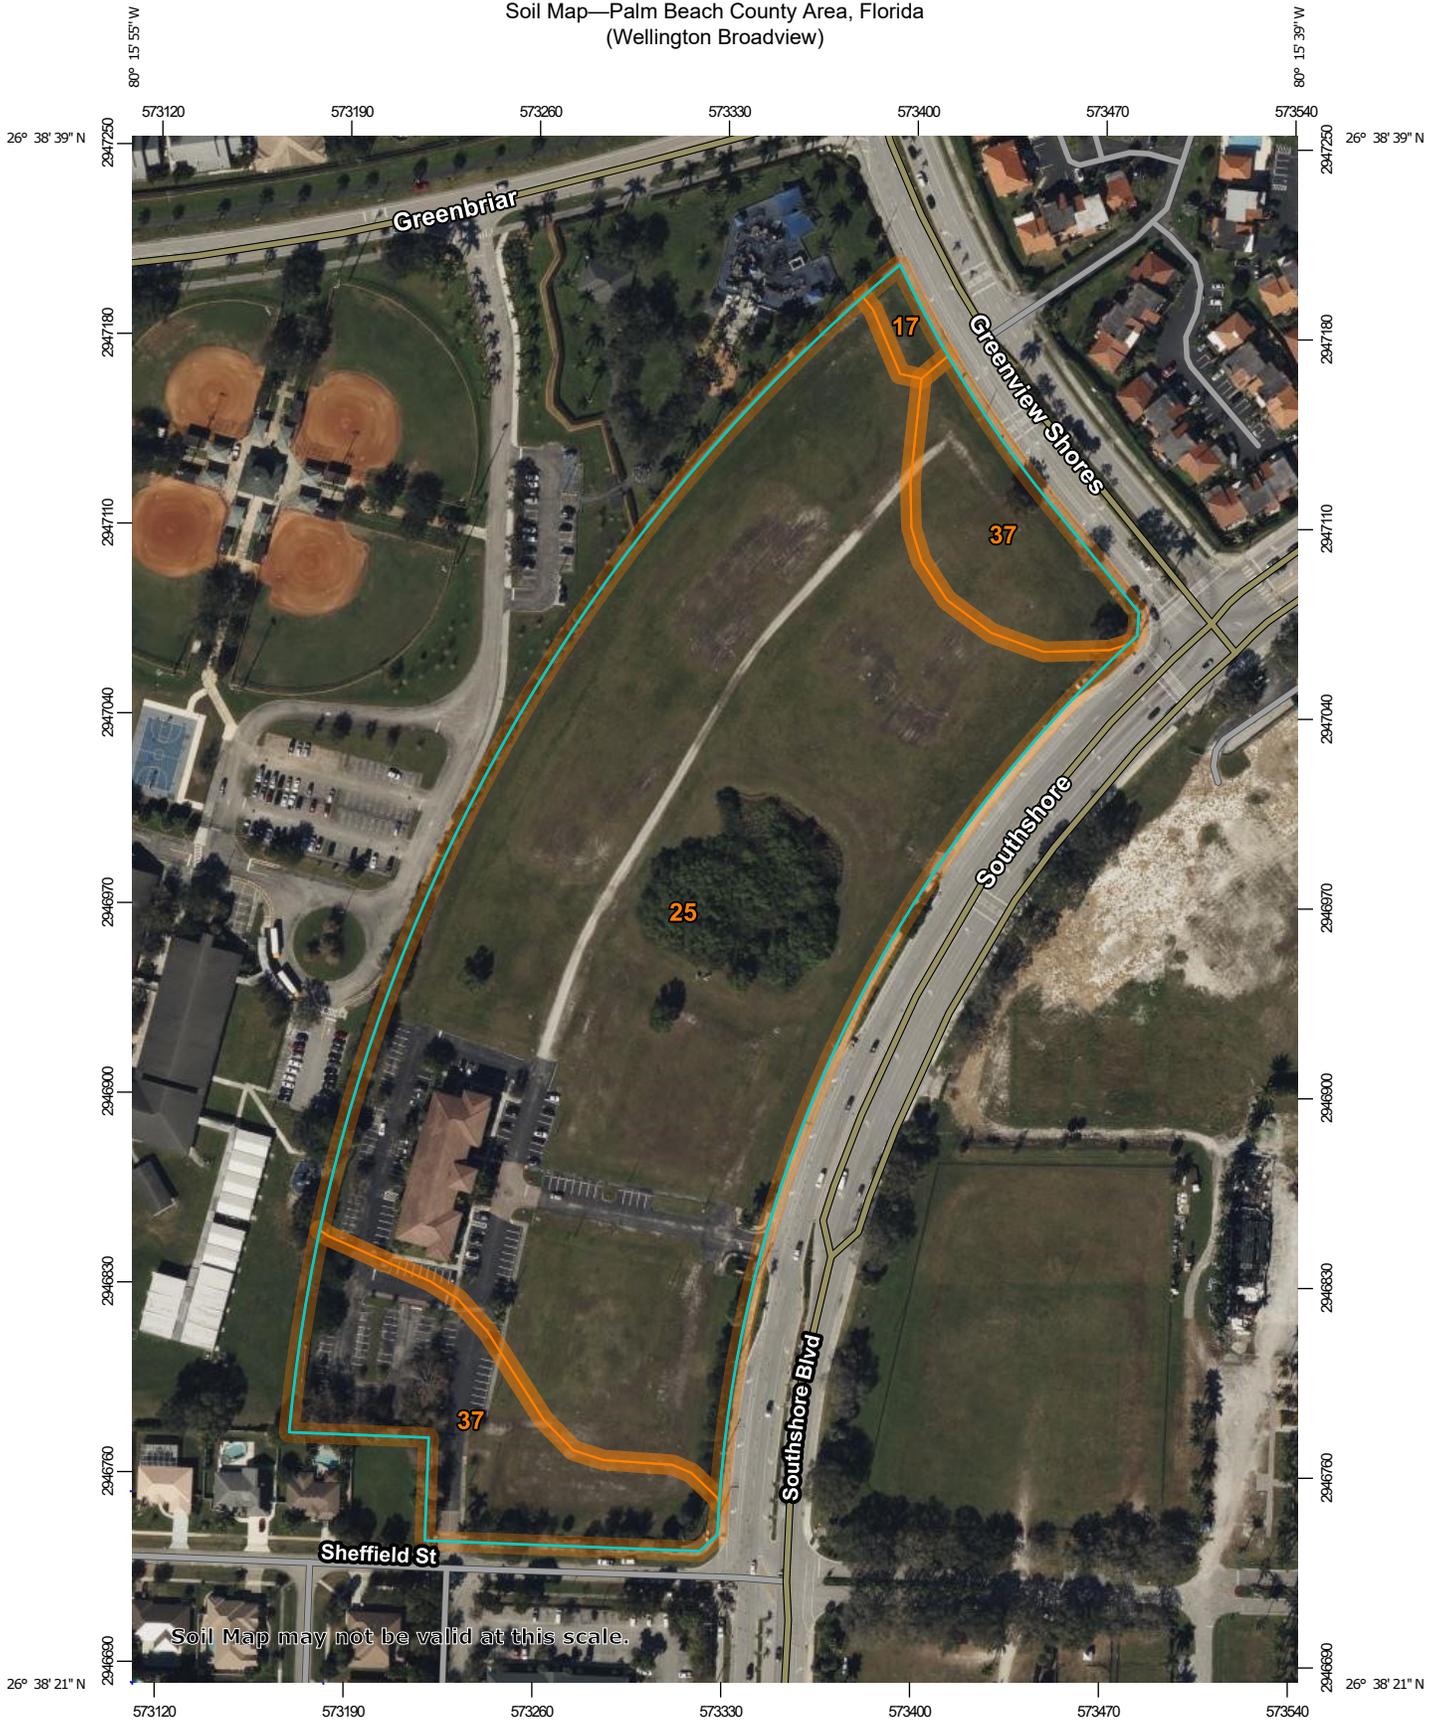
Soil Map—Palm Beach County Area, Florida  
(Wellington Broadview)

The soil on the site is mapped as Holopaw fine sand, 0 to 2 percent slopes, Oldsmar sand, 0 to 2 percent slopes, and Riviera fine sand, frequently ponded (depressional), 0 to 1 percent slopes. A description of each soil type in its natural condition is listed below. The description is based upon the general characteristics for the soil type as illustrated in the Soils Survey of Palm Beach County Area, Florida and is not necessarily indicative of the exact characteristics of the parcels. A soils map with the site boundary is included in the Appendix as an attachment.

Map Unit Symbol	Map Unit Name	Acres in AOI	Percent of AOI
17	Holopaw fine sand, 0 to 2 percent slopes	0.2	0.9%
25	Oldsmar sand, 0 to 2 percent slopes	14.4	80.6%
37	Riviera fine sand, frequently ponded, 0 to 1 percent slopes	3.3	18.5%
<b>Totals for Area of Interest</b>		<b>17.8</b>	<b>100.0%</b>

Halopaw fine sand, 0 to 2 percent slopes (17). This is a nearly level, poorly drained soil that has a thick sandy surface layer and loamy subsoil at a depth of 40 to 72 inches. This soil is on broad low-lying flats and depressions. Under natural conditions the water table is within 10 inches of the surface for 2 to 6 months during most years. Depressions are covered by water for 6 months or more in most years. The typical natural vegetation is saw-palmetto, slash pine, cypress, cabbage palm, inkberry, southern bayberry, sand cordgrass, broomsedge bluestem, blue maidencane, pineland three-awn, and other grasses.

Oldsmar sand, 0 to 2 percent slopes (25) – This is a nearly level, poorly drained, sandy soil that has a dark colored, weakly cemented layer below a depth of 30 inches over a loamy layer. It is in broad, flatwood areas. Under natural conditions the water table is within 10 inches of the surface for 1 to 3 months during most years. It is within 10 to 40 inches for 6 or more months in most years and recedes to below 40 inches in extended dry periods. The typical natural vegetation is saw-palmetto, slash pine, cabbage palm, inkberry, southern bayberry, pineland three-awn, blue maidencane, fetterbush, broomsedge, bluestem, and a variety of other grasses.

Riviera fine sand, frequently ponded, 0 to 1 percent slopes (37) Riviera fine sand, depressional is described as a nearly level, poorly drained, soil with a loamy subsoil. The soil is covered with up to two feet of water for more than six months each year. Typical natural vegetation may include cypress, needle grass, St. John's wort, corkwood, melaleuca, pickerelweed, maidencane, sand cordgrass, and other water tolerant plants.
